Habitat Connectivity and Restoration Potential Assessment of Deer Lake Brook in Burnaby, BC

Review of the Connection Between Two Western painted turtle Occupied Sites in an Urban Environment

April 2012

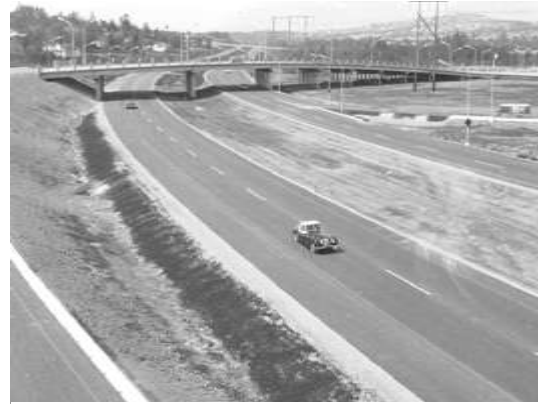
Figure 2: 1960's, the Trans-Canada Hwy. through Burnaby. Photo from BC Archives.

In the 1940's, planning for the Vancouver to Surrey section of the Trans-Canada Highway began (th.gov.bc.ca, 2000). Upon completion in the early 1960's, the highway consisted of two three-lane sections running past the south-west side of Burnaby Lake Regional Park (Fig. 2). Deer Lake Brook flows under the highway through a 110m long concrete culvert.

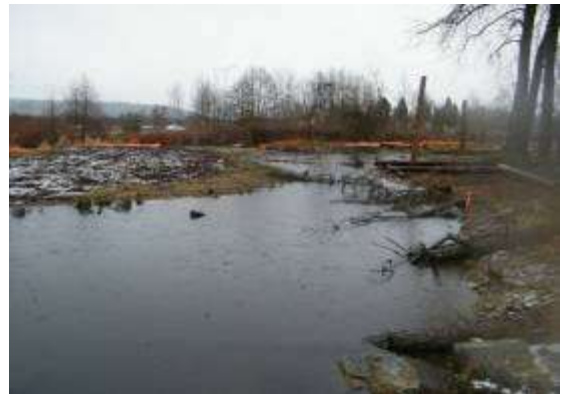
In early spring 2011, construction began on the Burnaby section of the Port Mann/Highway 1 Improvement Project (PMH1). As part of the project, the stretch of highway running through Burnaby will receive an extra lane in each direction (PMH1 Project, 2012). The section of land between the Trans-Canada highway and Glencarin Drive has been covered due to this expansion. As well, road upgrades and lane expansions will take place on the Kensington Ave. and Sprott St. overpasses in order to improve traffic flow. Included in the PMH1 are habitat enhancement projects, one of which is in the Kensington Interchange area (Fig. 3). Deer Lake Brook flows through the northeast quadrant of the Kensington area and work is being undertaken to enhance fish habitat in the brook by creating small ponds off the main water channel (PMH1 Project, 2012).

Figure 3: Habitat enhancement occurring near Deer Lake Brook at the Kensington Interchange as of Jan. 30, 2012. Photo by Deanna MacTavish.

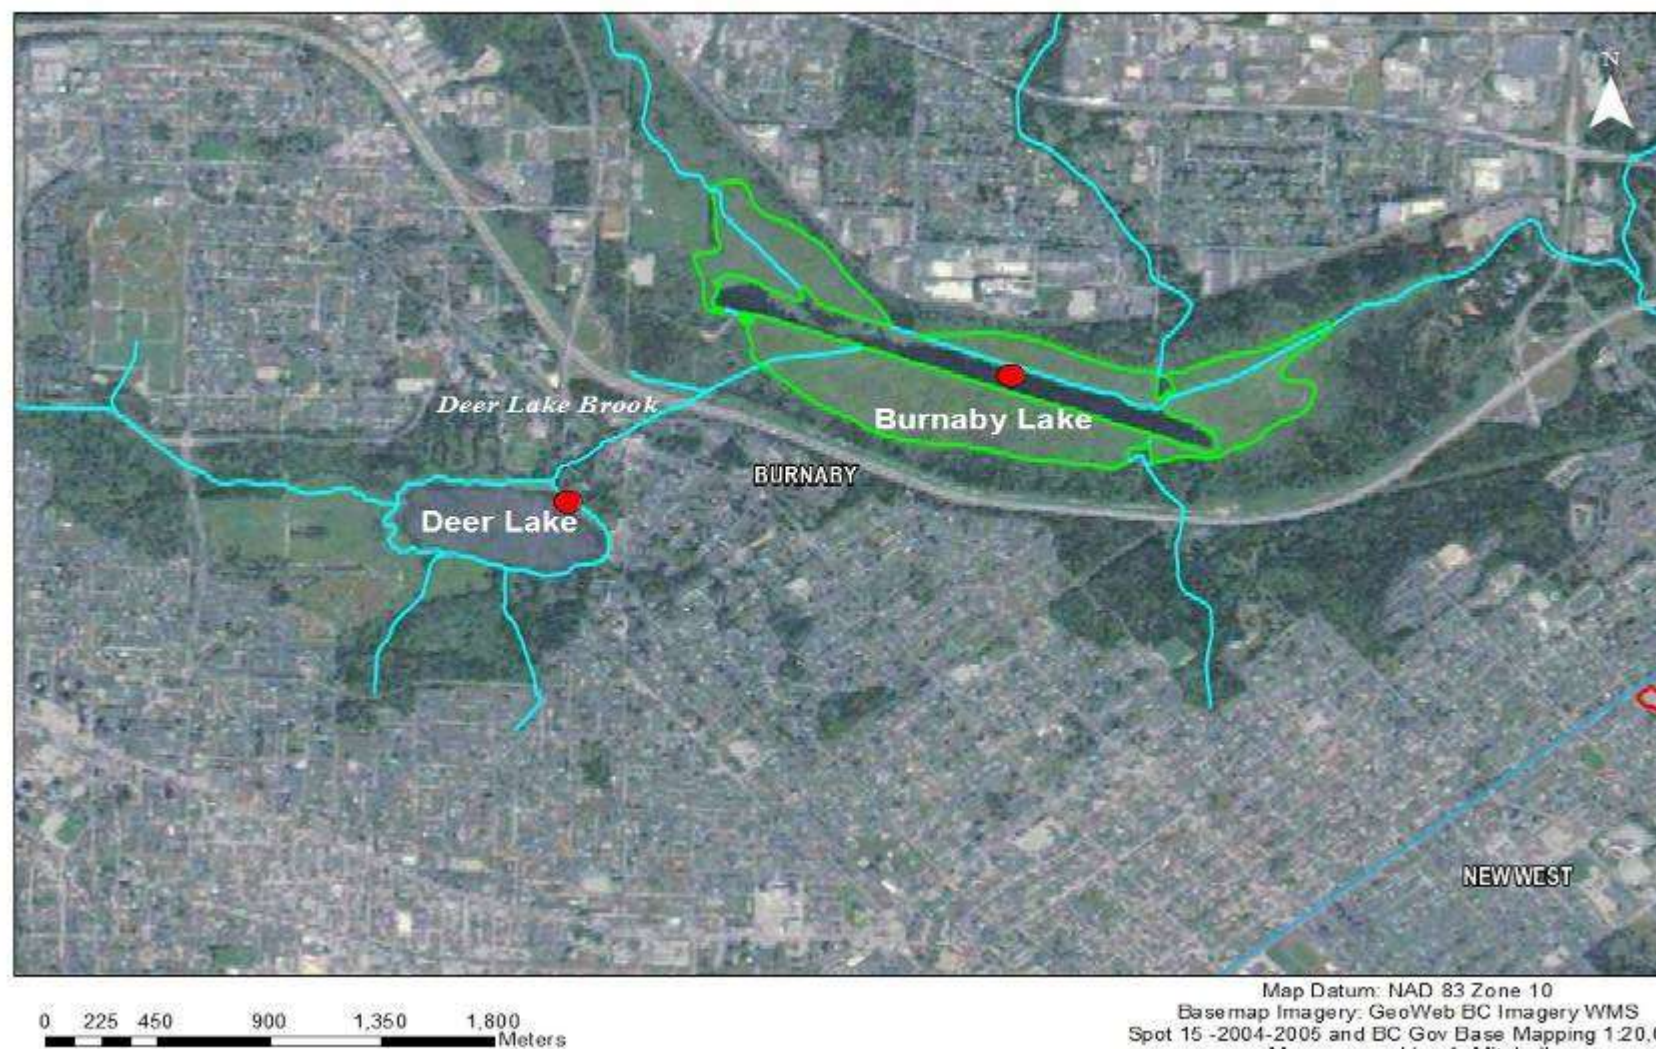
Figure 4: Current map of Deer Lake, Deer Lake Brook and Burnaby Lake in the City of Burnaby, BC. Red dots are western painted turtle Occurrences.

Deer Lake Brook represents the primary aquatic habitat that connects two western painted turtle occupied sites in the City of Burnaby in South Coast region of British Columbia (Fig. 4). Deer Lake is a moderate-sized urban lake and was once a popular swimming destination (VI, 2011). Other recreational activities, such as fishing, non-motorized boating and hiking/walking, are still very popular, resulting in the heavy use of this lake and surrounding parkland in the spring and summer. Parkland surrounds the entire lake as part of Deer Lake Park (including 5.6 km of walking paths); city buildings are situated on the north end within 100 m of the lake edge, and residential development is present on the east and southeast sides of the lake (City of Burnaby, 2011c).

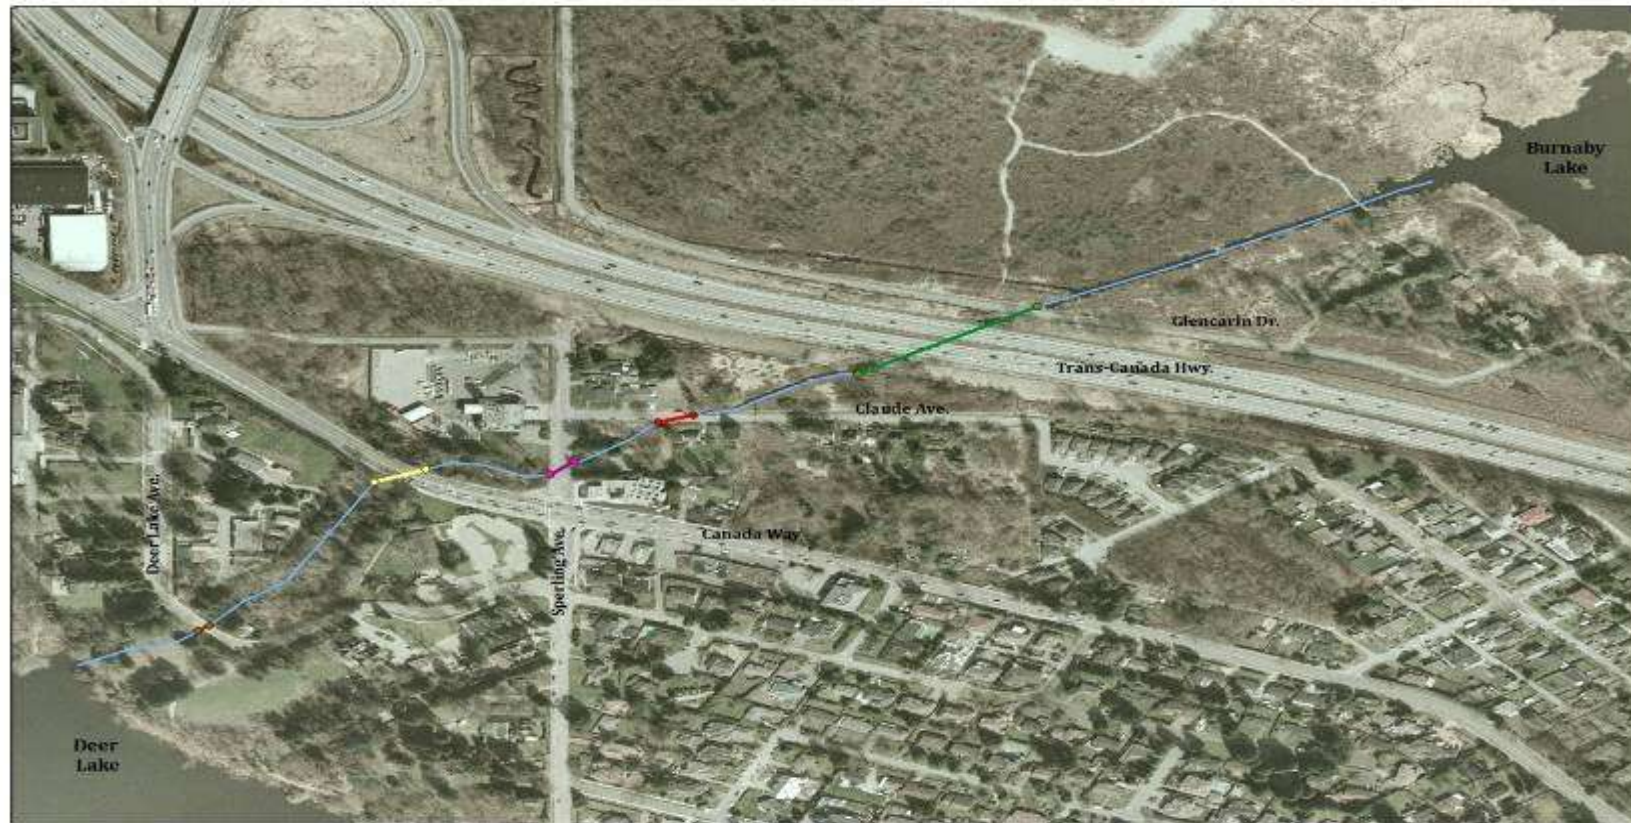
Figure 6: Road crossings over Deer Lake Brook from Deer Lake to Burnaby Lake. Mapped in 2012 using ArcMap.

Baseline data were collected for all road crossings along Deer Lake Brook in the winter of 2012 (Table 2) in order to determine potential use of the brook as a wildlife corridor between Deer Lake and Burnaby Lake. GPS (Global

Positioning System) coordinates of the crossings (Fig. 6) were obtained in order to create an appropriate map of crossings along the brook. Vegetation cover, substrate and coarse woody debris data were also collected along the length of the brook and averages between crossings were recorded. Vegetation buffer data were also collected along the length of the brook on both sides of the stream bank and averages between crossings were recorded.

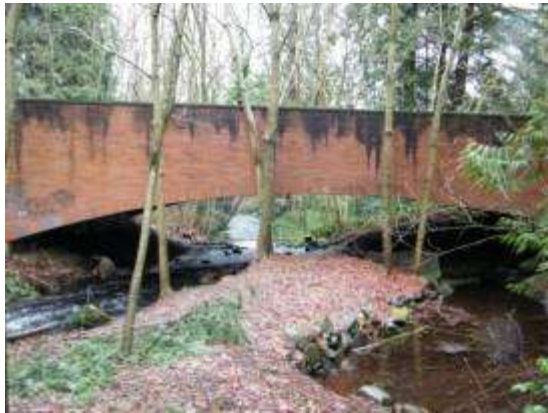
Figure 7: Crossing 1 over Deer Lake Brook.
Photo by Deanna MacTavish.

The first roadway to cross Deer Lake Brook (Crossing 1) is a two-lane road known as Deer Lake Avenue. Deer Lake Ave. crosses over the brook via an 8m wide brick bridge (Fig. 7). A chain-link fence, which delineates the property line of the Burnaby Village Museum, straddles the brook on the downstream side of the bridge. This fence may hinder terrestrial species movements along the corridor and should potentially be removed. Crossing 2 (Fig. 8) is a large concrete culvert with a metal grate covering the upstream opening. The 25m long culvert runs under Canada Way, which is comprised of four traffic lanes. Light is visible from this end of the culvert. The metal grate on the culvert does not allow mid to large sized species to pass through and would prevent these species from using the culvert as a corridor.

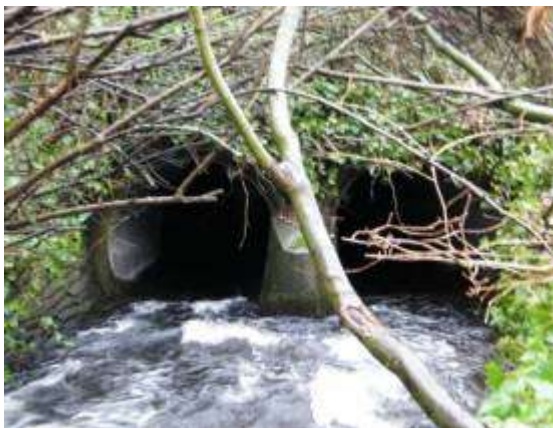
Figure 9: Crossing 3 over Deer Lake Brook.
Photo by Deanna MacTavish.

Crossing 3 (Fig. 9) includes two side-by-side 1m concrete culverts. The 21m long culverts run underneath Sperling Avenue, which is comprised of two traffic lanes. While still having light visibility, the narrow diameter and length of these culverts may discourage their use by organisms using the brook as a corridor. Crossing 4 (Fig. 10) is a 25m long, large metal culvert running underneath Claude Avenue, which is two traffic lanes wide. The large size of the culvert allows light to be visible from both ends and allows passage for organisms of all sizes.

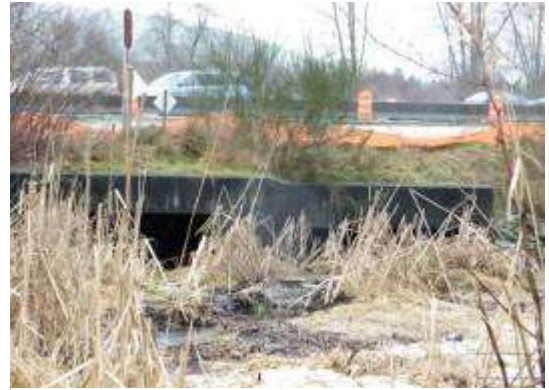
Figure 11: Crossing 5 along Deer Lake Brook. Photo by Deanna MacTavish.

Crossing 5 (Fig. 11) is comprised of two side-by-side rectangular concrete culverts which are approximately 110m in width. The culverts pass underneath the eight-lane wide Trans-Canada Highway as well as the two-lane wide Glencarin Drive. Light is not visible at the ends of these culverts and their extreme length may discourage their use by species using the brook as a corridor.

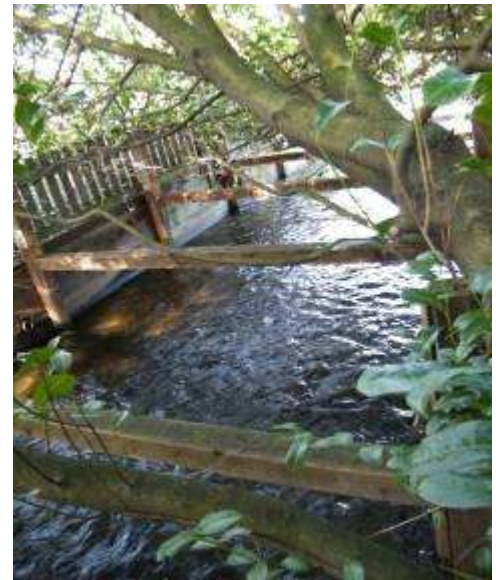
Figure 12: Wooden beams and embankments along Deer Lake Brook between Crossings 3 and 4. Photo by Deanna MacTavish.

in metal up to Crossing 4. The installation of the beams was most likely to prevent stream-bank erosion as the stream-banks on both sides of the brook are very steep. The wooden beams, as well as the metal and wooden embankments, appear to be in good condition. The relatively smooth wood and metal stream-banks, as well as the lack of in-stream debris may pose a threat to terrestrial and semi-aquatic species as they may have a difficult time climbing out of the brook.
